Analysis of Soil Movement Hazards Trigger on Main Road Segment Denpasar-Singaraja in Baturiti District, Tabanan

I Nengah Sinarta*, A. A Gede Sumanjaya, I Wayan Ariana Basoka
{inengahsinarta@gmail.com}

3
Departement of Engineering and Planning Faculty, Universitas Warmadewa, Denpasar, Bali, Indonesia

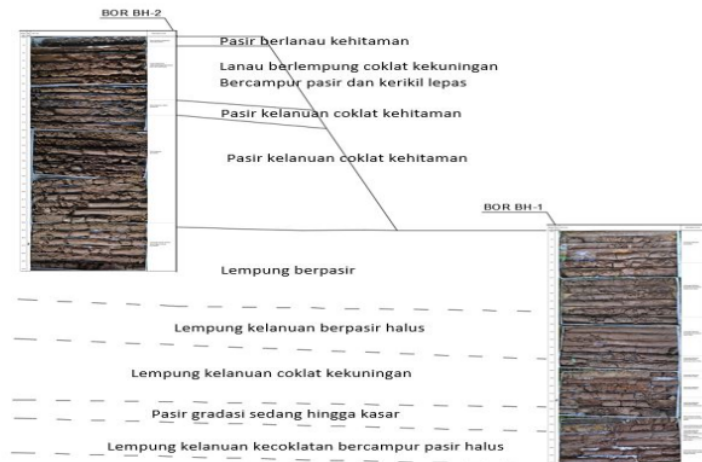
Figure 2. Data Drill

Based on the drill data, it can be seen the description of the soil in Fig 2. as follows: at depth of 0.00 from the topsoil to a depth of 1.00 meters in the form of blackish silty sand mixed with gravel. Then from a depth of 1.00 meters to 8.00 meters in yellowish-brown loamy silt mixed with sand and loose gravel. Then from a depth of 8.00 meters to 10.00 meters in the form of blackish-brown silty sand. Then from a depth of 10.00 meters to 24.00 meters in the form of brownish silty sand. Then from a depth of 24.00 meters to 30.00 meters in sandy loam with acceptable to medium brown gradations. The groundwater level was found at a depth of -26.80 meters.

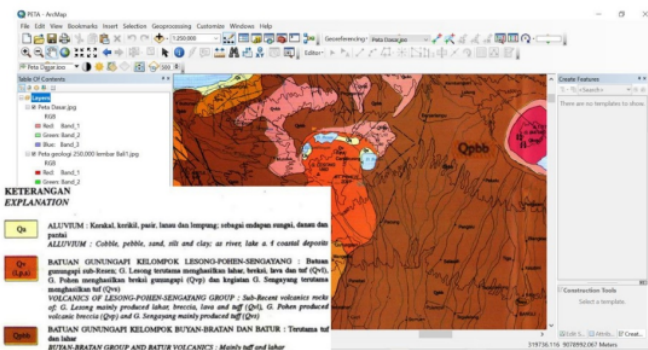
Figure 3. Geological Map of the Research Area

The Geological Conditions based on geological map sheets of Bali Nusa Tenggara [10], the analysis was carried out with the help of Arc-GIS software to help overlay as shown in Figure 3, where the geological conditions at the project location are in mountainous areas, there are two rock formations, namely; extruded rock from Mount Batukaru and volcanic rock from the sub recent cones of Mount Pohen, Mount Sangiang, and Mount Lesong. The constituent rocks are Qv rocks which are volcanic rocks of the Lesong-Pohen Sengayang group, and there are Qpbb rocks which are volcanic rocks of the Buyan-Bratan and Batur groups, especially tuff and lava; there are no geological structures in the form of faults or faults in this area.
