1 GEOTECHNICAL PROPERTIES AND GEOLOGICAL AGE ON CHARACTERISTICS OF LANDSLIDES HAZARDS OF VOLCANIC SOILS IN BALI, INDONESIA

5
I Nengah Sinarta¹, Ahmad Rifai¹, Teuku Faisal Fathani¹, and Wahyu Wilopo²

International Journal of GEOMATE, Oct., 2016, Vol. 11, Issue 26, pp. 2595-2599.

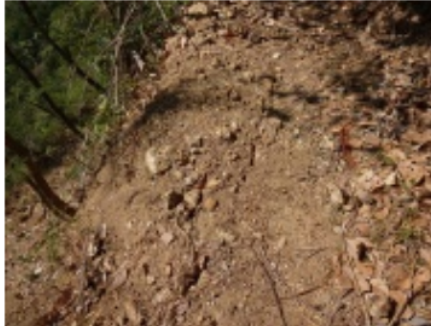
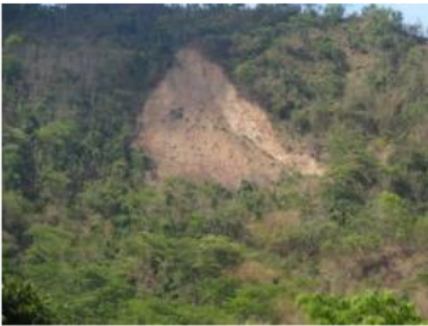
Fig. 2. The types of ground movement at Sega village

a. fault creep

b. Translation into Debris flow

and potentially to create soil movement in the form of subsidence and landslides (Fig. 2).

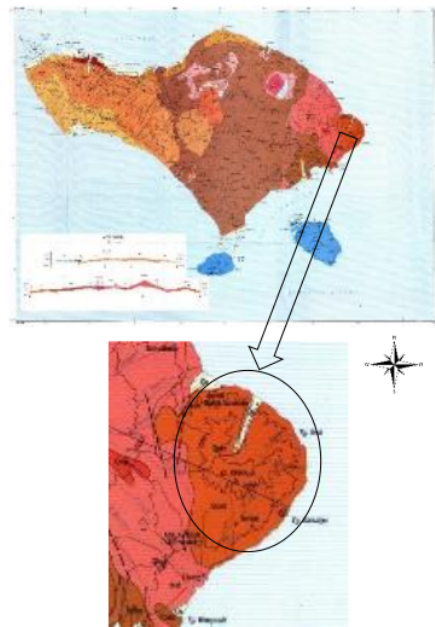
Fig. 3. Regional Geology.

In general, topography and geological conditions (Fig. 3) in a disaster area and surroundings are the area with the moderate to steep slopes. The location of the movement is on the height above 50 meters above sea level. Based upon the Geological Map Sheet of Bali (Purbohadiwijoyo MM, et al, P3G, 1998) prepared by the disaster area

by structured Lava rocks of Mount Seraya comprising weathered lava rock alternating breccia (Qpvs).

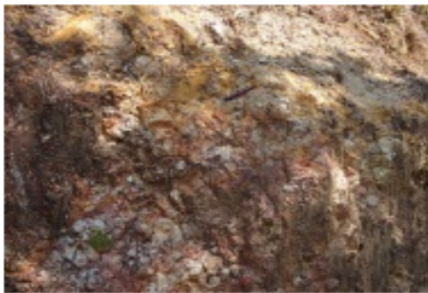
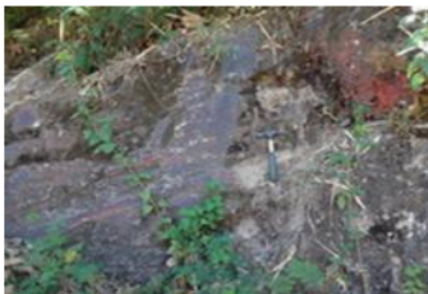
a. Sandstone silk with clay

b. Shale outcrop bluish gray clay

Fig. 4. Outcrops of volcanic soil of Sega village
The geotechnical parameter and weathering degree of volcanic rock are two factors determining the occurrence of landslides (JJ Bommer et.al, 2013). The weathering of rocks and soil in the study

area is structured by volcanic breccia, breccia tuff and lava including the insertion of the sandstone and bluish gray clay, the surface part of which has experienced the weathering in the form of quite thick sandy-loam silty clay. Clay, sandy or silt soils are the types of soil that can easily pass the water. If the soil is located above the impermeable rock at a specific slope, then the incoming water will be retained and the soil at a certain slope will potentially slip to be a landslide. The recapitulation of geotechnical parameters based upon the results of sampling in field and laboratory testing is shown in Table 1 and Table 2.

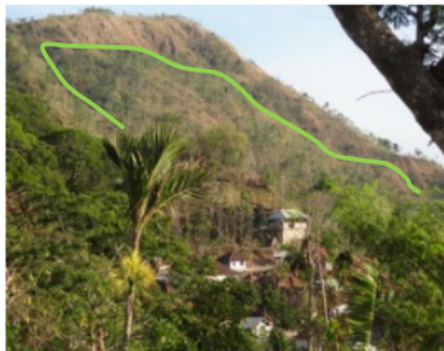
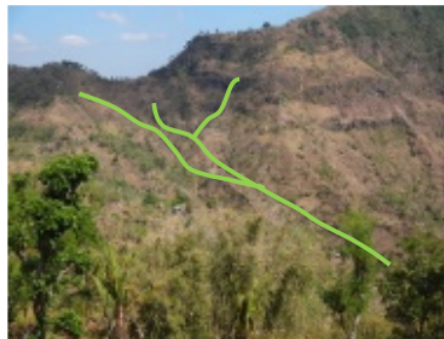
Fig. 5. The shape and behavior of ground motion in Sega Village

a. Creep/settlement

b. Debris flow

Meanwhile, the shallow avalanches occur due to the long term moderate rainfall involving the movement of debris, rock fragments, coarse and medium sand and vegetation slope (C Meisana, 2007). Landslide shows (Figure 5.) a combination of two or more types of movement as the accumulation of the complex types (Varnes, 1984) and can be triggered by a number of external factors, such as intense rainfall, changes in water level, storm surge, or erosion fast flow (Dai et. al, 2002). The geological structures were also found in the study area including rock fractures and bedding. Fracture was found mainly in the region that has a very steep slope experiencing the cut underneath.
