Analysis of selection criteria of bridge/shortcut construction on national road denpasar – Gilimanuk FREE

AIP Conference Proceedings 2599, 070029 (2023) https://doi.org/10.1063/5.0120610

Analysis of Selection Criteria of Bridge/Shortcut Construction on National Road Denpasar – Gilimanuk

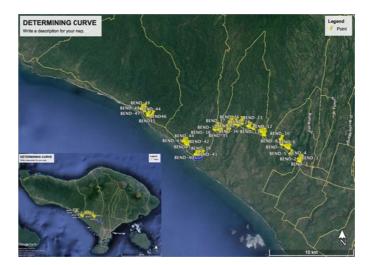
FIGURE 1. Map for Determining alignment horizontal

Horizontal alignment refers to the road's horizontal shape in a specific plane, which might enhance comfort, and security. Horizontal alignment, often known as "road alignment" or "road situation," is created by connecting straight lines with curved lines [5]. The preliminary survey will first use map data to locate horizontal alignment data, which will then be examined to see how many curves do not standard Bina Marga criteria [6]. Table 1 shows the design speed chosen with the road function for hills [7]

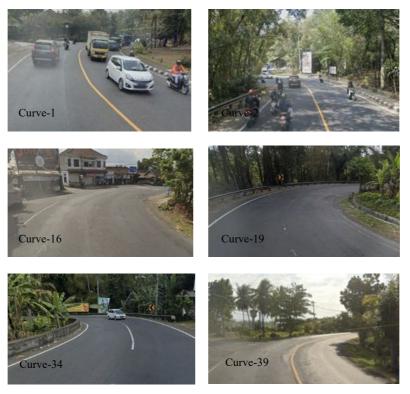
FIGURE 3. Documentation of the bend conditions based on the results of field surveys.

Along the area reviewed there are 53 Curves. Here is a documentation of the bend conditions based on the results of field surveys.

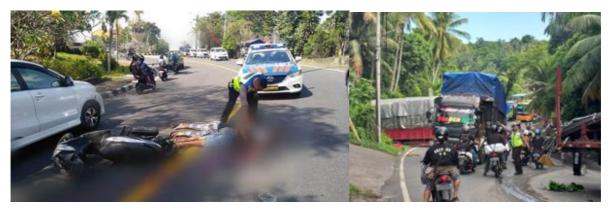
FIGURE 4. Photos of traffic accidents and traffic jams

Here is documentation of accidents and congestion that occur at the research site, based on the findings of field surveys and secondary data acquired some curves that are prone to accidents and congestion.

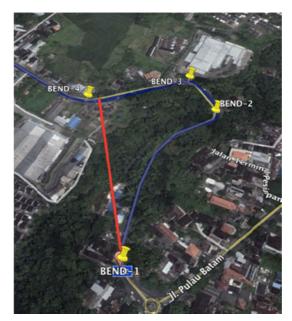
FIGURE 5. Curve layout 1-3.

From the picture above shows the number of curves 1-3. The superelevation at curves 1 to 2 does not meet road safety rules, so it is proposed that a shortcut from curve 1 cuts to bend 4. Shortcut recommendations are proposed because the land is still available in this area. This shortcut is expected to improve road safety and comfort to minimize the occurrence of accidents and faster travel times.
